Earthen Waste Storage Structures in Iowa

A Study for the Iowa Legislature

August 1999

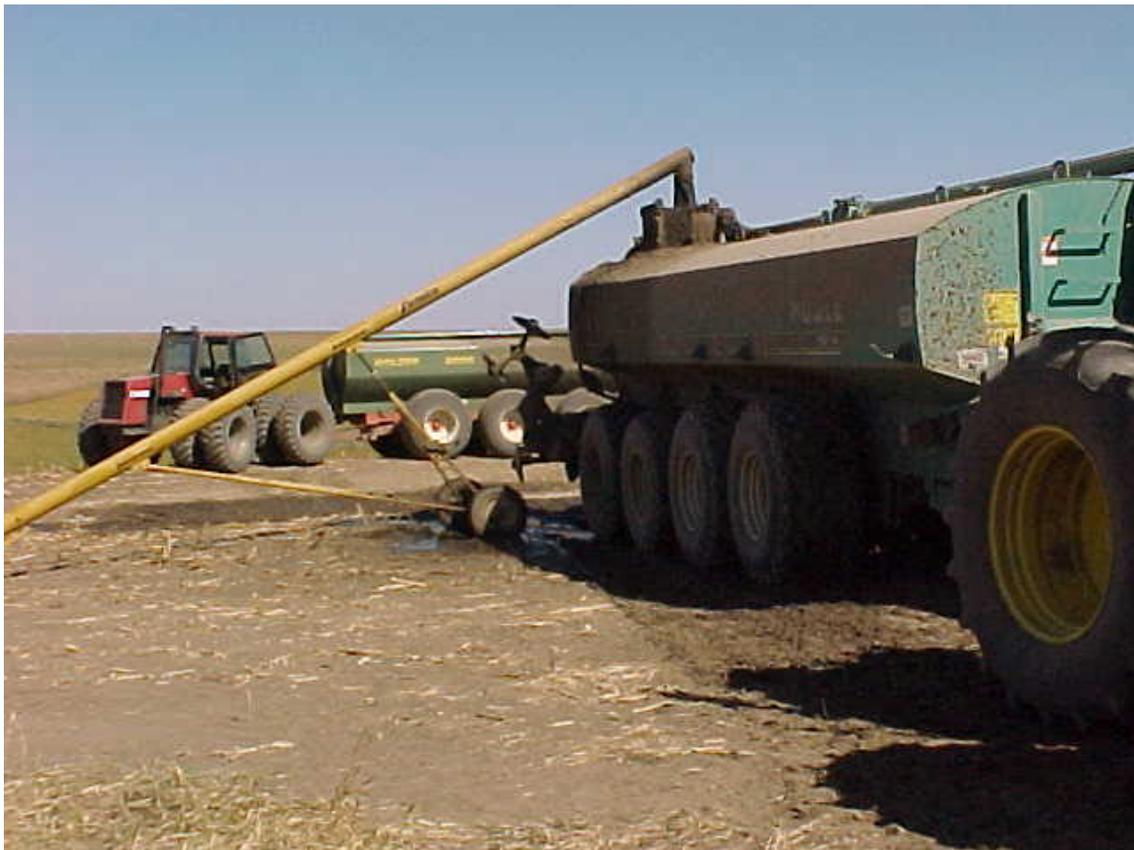
Figure 1. Manure spillage during tank loading operation

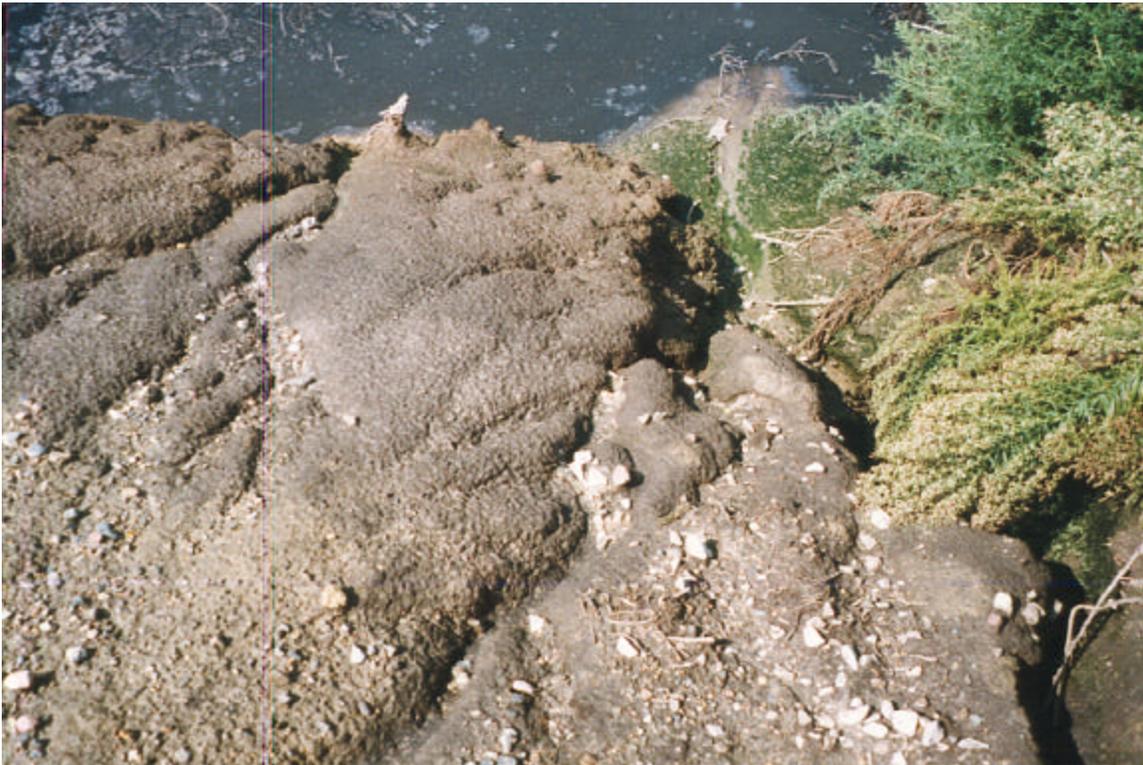
The second most common concern identified by this survey was erosion of the compacted soil or clay liner, with significant impacts at 27% of the sites surveyed. Erosion was found at inlet pipes, pump out locations, and along the sides of the berm where agitation jet streams had been stationary for extended periods (see Figure 2). Inlet pipe erosion can easily be addressed with the installation of stone rip-rap or concrete at critical locations, and is recommended wherever inlet pipes could discharge onto the berm when manure levels are low. The causes of erosion at pump-out locations were not always obvious, but may be associated with cleaning out manure transport and application equipment. Agitation induced erosion results when the agitation jet stream is not kept in constant motion near the berm of the storage. Even a few moments of high-volume flow directly on the soil surface are capable of considerable liner erosion. Although effective agitation requires attention to the corners and recesses of the storage to insure adequate suspension of manure solids (USDA, 1997), agitator operators must pay particular attention to the damage this operation can cause.

Figure 2. Berm erosion caused by agitation or backwash during pump-out.

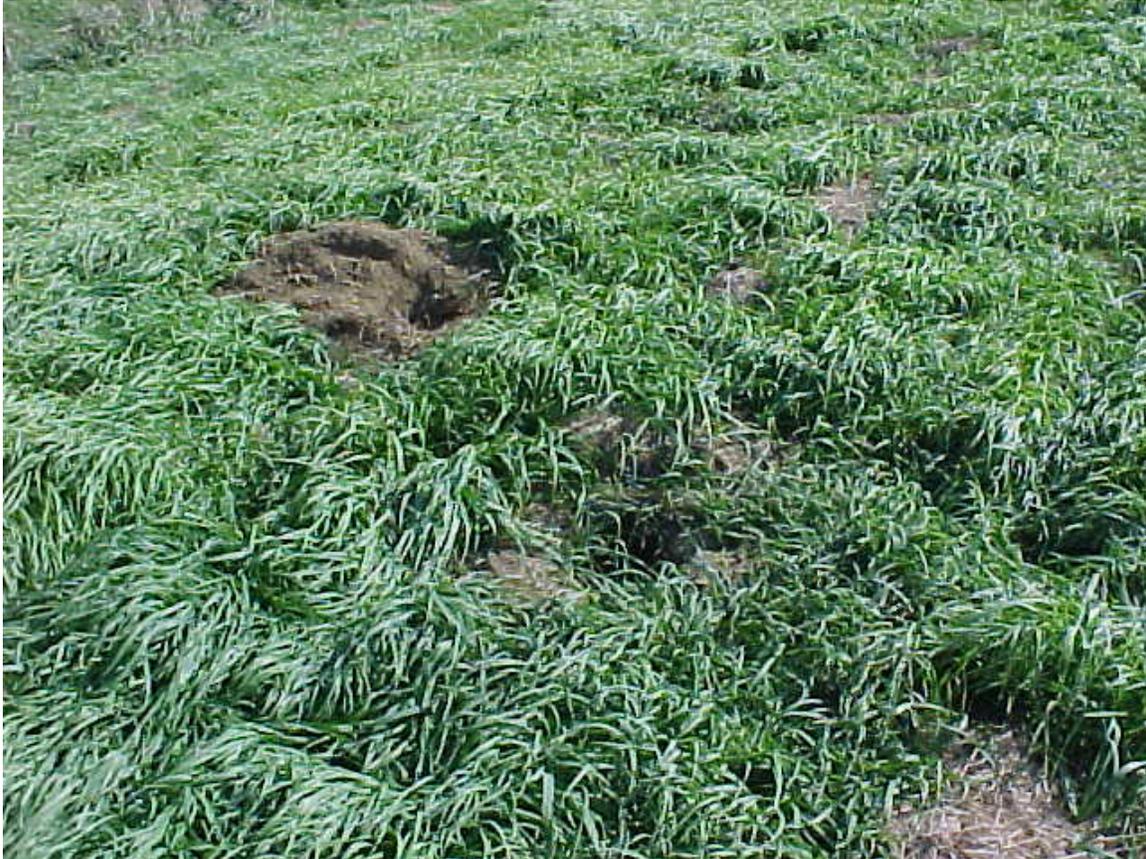
Evidence of animal burrowing was observed at 24% of the sites. Burrows were found on both inner and outer sides of the berm (see Figure 3), as well as adjacent to inlet pipes, valves, and other manure control structures. Fluctuating manure levels make these burrows particularly problematic, since a burrow can be built directly through the berm in

dry soil when the liquid level is low, and become an effective pipeline when liquid levels are high. Even if burrows do not result in surface leakage outside the berm, they can compromise the compacted liner and allow manure movement to more permeable zones adjacent to the structure. Inspection and maintenance to detect and eliminate burrowing animals should be a regular part of earthen manure structure management (USDA, 1997).

Figure 3. Animal burrows in berms can become conduits for manure, especially if they are submerged as the earthen structure fills to capacity.

Inspection for animal burrowing is obviously facilitated by frequent mowing of the berms. Although the facilities surveyed generally indicated they mowed their berms at least once a year, several had extremely high grass growth, particularly on the inside of the berms. The inner slope of many earthen structures is relatively steep, with design recommendations ranging from 1.5:1 to 3:1 (horizontal to vertical) (USDA, 1997). This slope was often considered too steep to mow by facility operators. At 6% of the sites, neglect of mowing had allowed the establishment of trees on the berm (see Figure 4). As with burrowing, fluctuating storage levels make tree growth a particular concern, since root channels established during low liquid levels can serve as conduits when manure

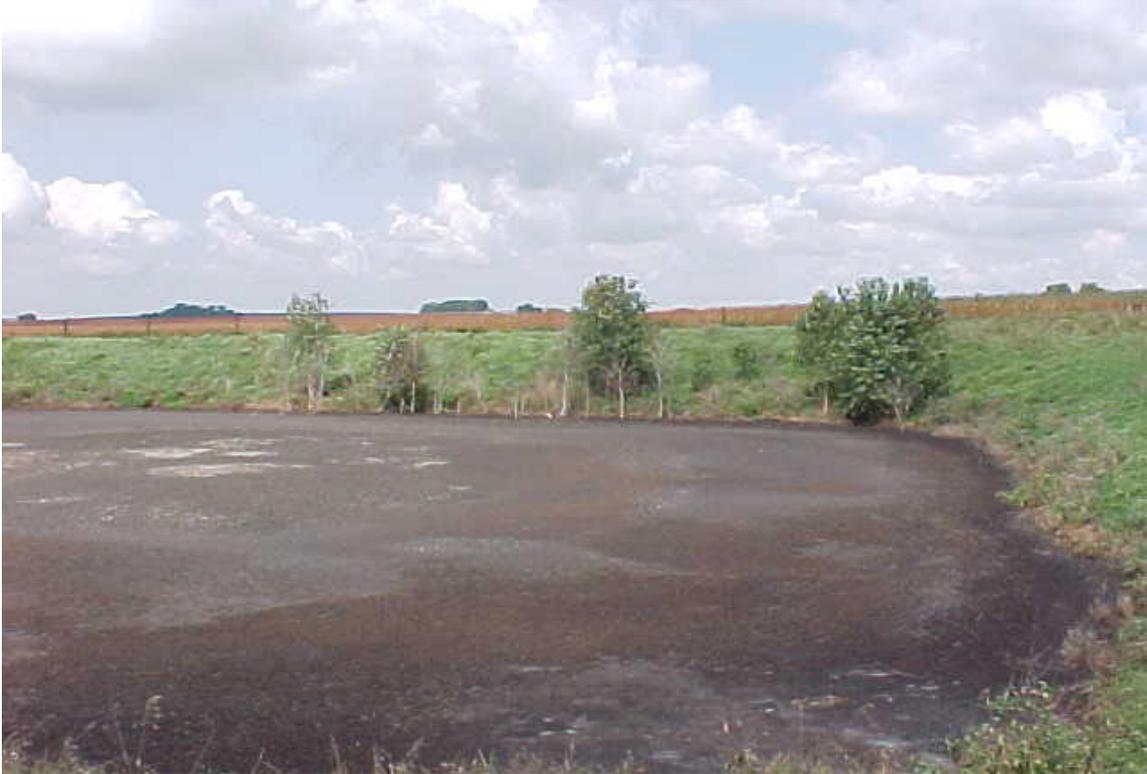
levels rise. The risk associated with this factor is expected to increase when trees die and decompose.

Figure 4. Tree growth in berms can create macropores for manure leakage.

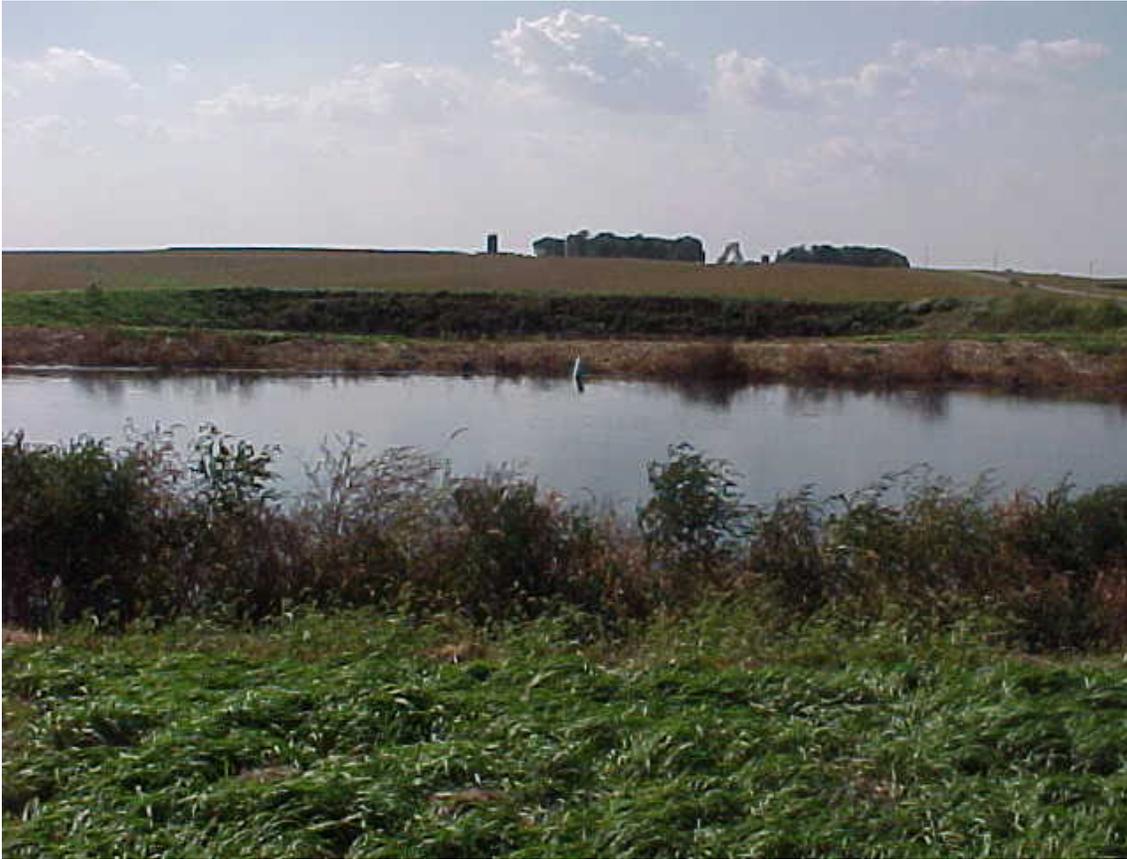
Inadequate freeboard was either directly observed or indicated by the operators at two (6%) of the facilities surveyed (see Figure 5). Although this was an uncommon problem, at one of the sites it had resulted in a major spill. The need for routine monitoring of manure liquid levels is widely recognized (USDA, 1997) and was one of the few management requirements included in permit conditions (see above).

Figure 5. Inadequate freeboard between berm and manure level.
